WATER GATE REPAIR ANGKAOL AND PONG TEUK COMMUNES

INTRODUCTION

Site Records

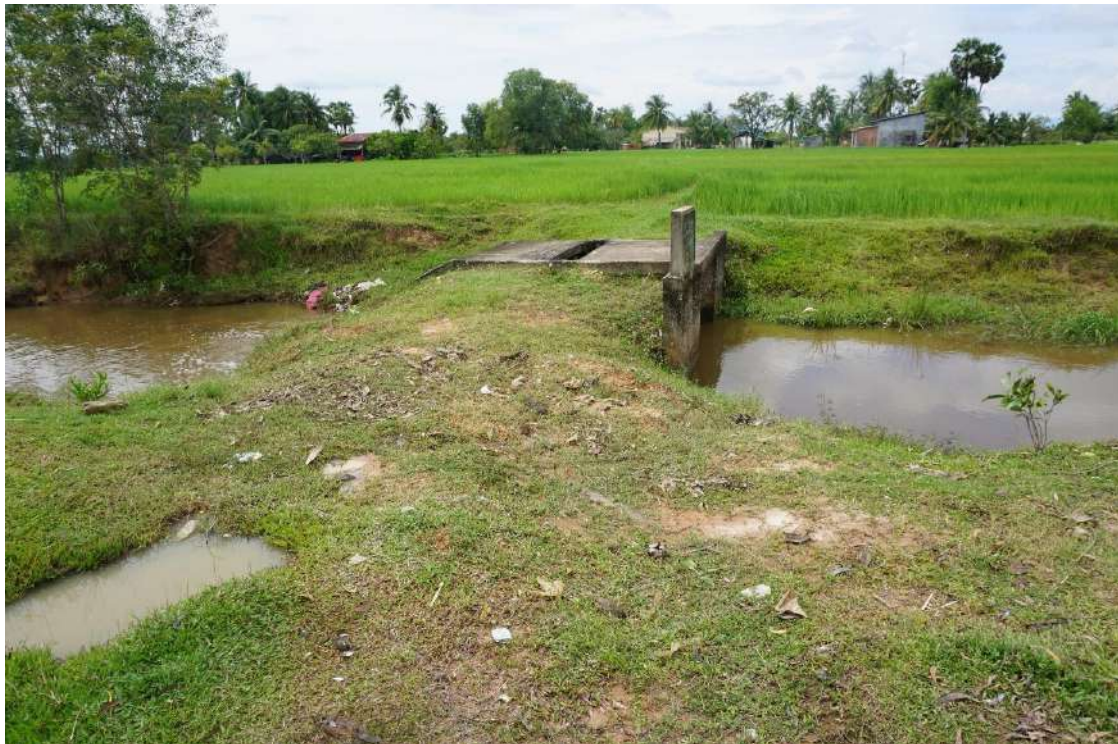
Figure 1 “Watergate 1 in Pong Teuk Commune”

- Watergate 1 is missing the spindles and gate and the surrounding embankment is eroded
- Watergate 2 is suffering from erosion at the embankment both upstream and downstream

Repair works on water gate one are slightly more comprehensive than the other gates. Water gate 1 needs a proper structure provided before two new spindles can be installed. To do so, the upper structure needs to be built with concrete and the also the lining around the gate, guiding the water, requires reconstruction.

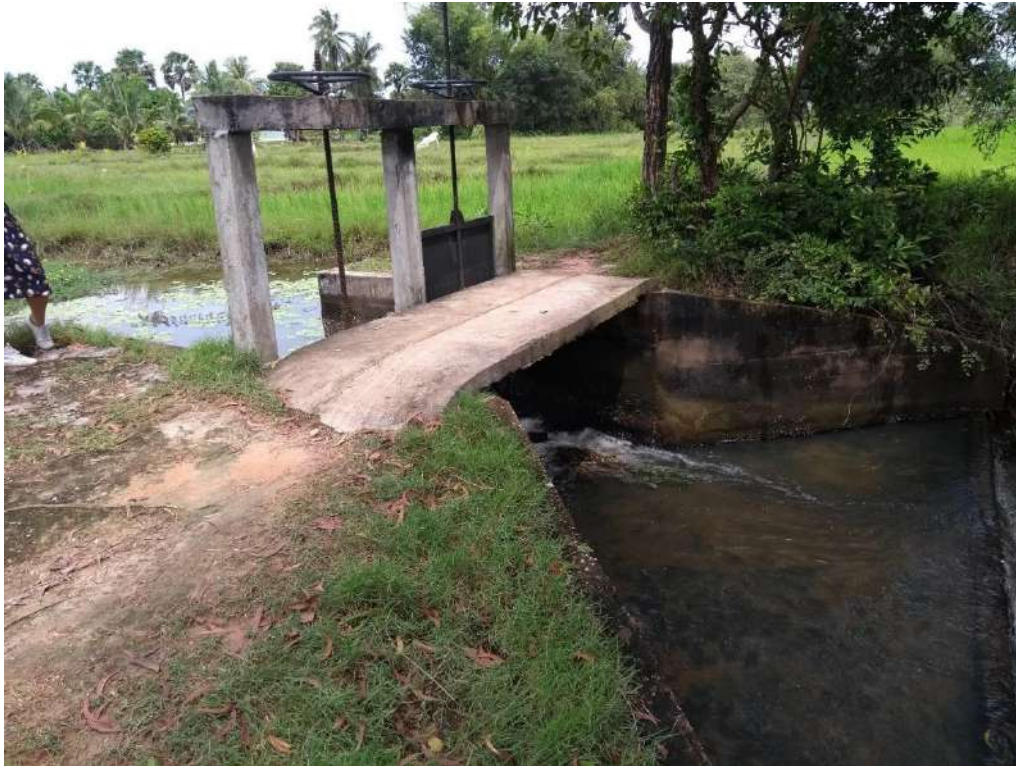
Figure 2 *“Watergate 2 eroding embankment upstream and downstream embankment in Angkaol Commune”*

The concrete lining of the embankment for water gate 2 needs to be repaired. Figure 5 gives the concrete lining that needs to be constructed. The concrete guiding the water towards the gate is in place already. The concrete in line with the gates is missing, therefore the embankment upstream and downstream is eroding.

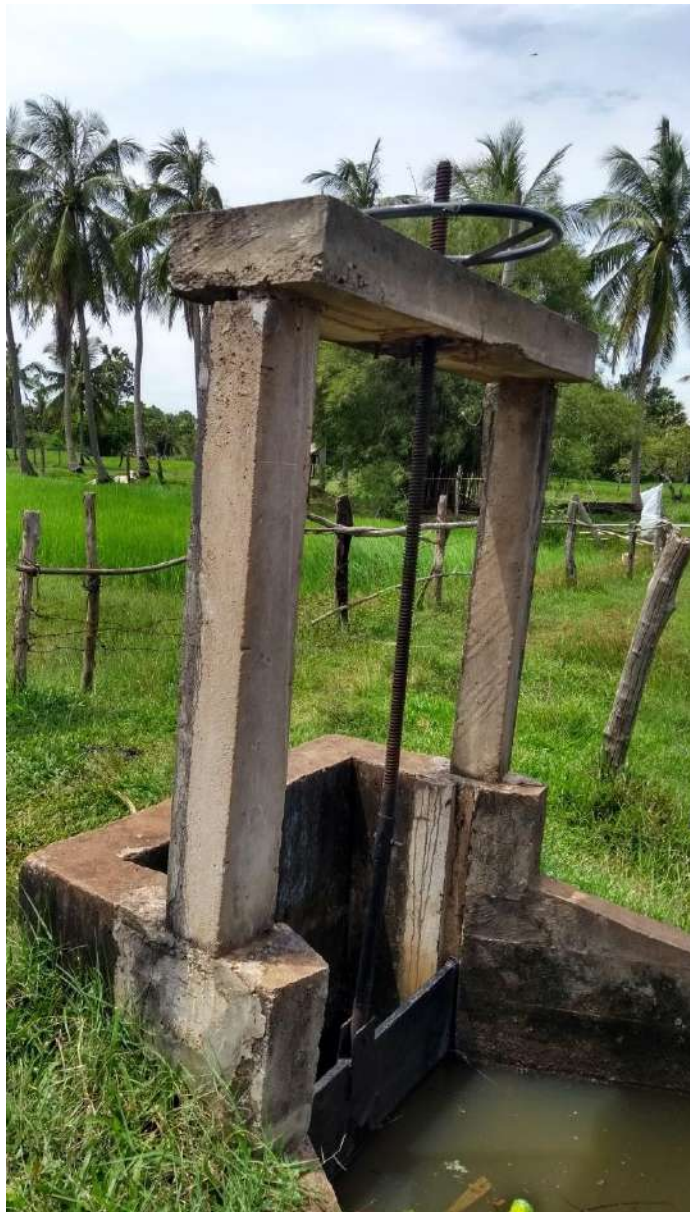
Figure 3 *“Watergate 3 scour underneath the watergate in Angkaol Commune”*

- Watergate 3 is having trouble due to scour on the gate bottom

This gate has problems with scour. The concrete under the gate is eroding therefore water is passing underneath the gate causing more erosion on the foundation of the structure.

The construction of the concrete base of gate 3 can be carried out applying the method as depicted in the figure below. Sandbags are used in combination with a pump to block the upstream water flowing in. The pump takes out the water that is seeping in. The gate is closed so water cannot flow backwards. In case the water cannot be stopped by the gate from flowing back completely sandbags can be applied on the downstream side of the gate equally. The method can be used for all three of the gate repair tasks.

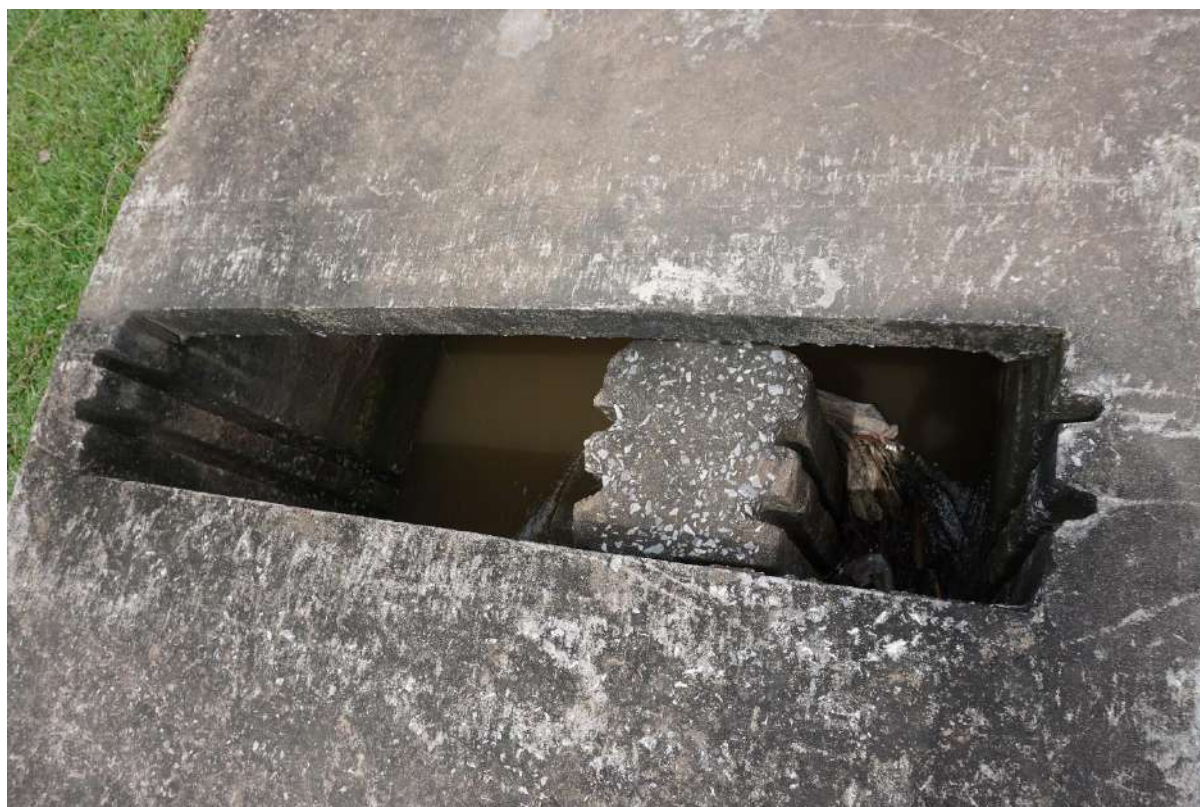
Figure 4 “Missing spindle in gate 1”

The frame supporting the spindles can be installed in the concrete frame, similar to the existing gates (figure 2). The dimensions for one of the two spindles and gate board is given in Table 1. In Figure 5 the dimensions represented in the table match the standard design.

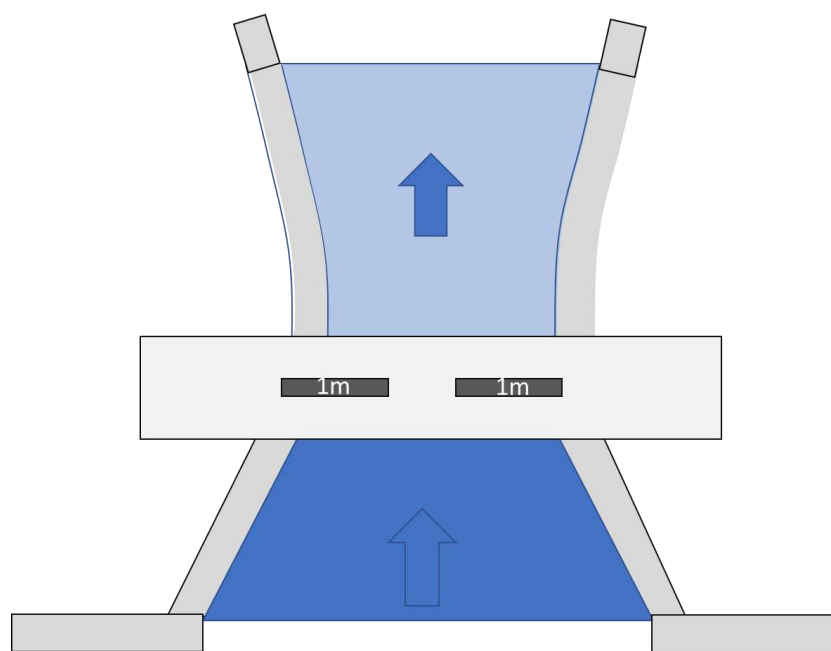
Figure 6 “Top view concrete water gate embankment”

Work on the embankment on gate 1 includes adding material to prevent from eroding. The concrete sides need to be rehabilitated with concrete and filling material.

The concrete thickness of the embankment is estimated to be 15 cm.

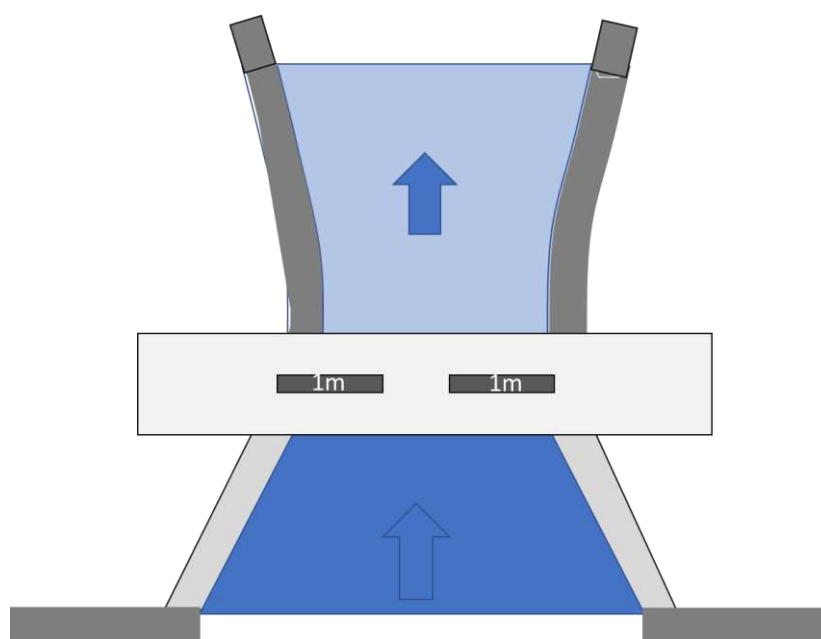
Figure 7 “Concrete lining in dark grey needs repair for Gate 2”

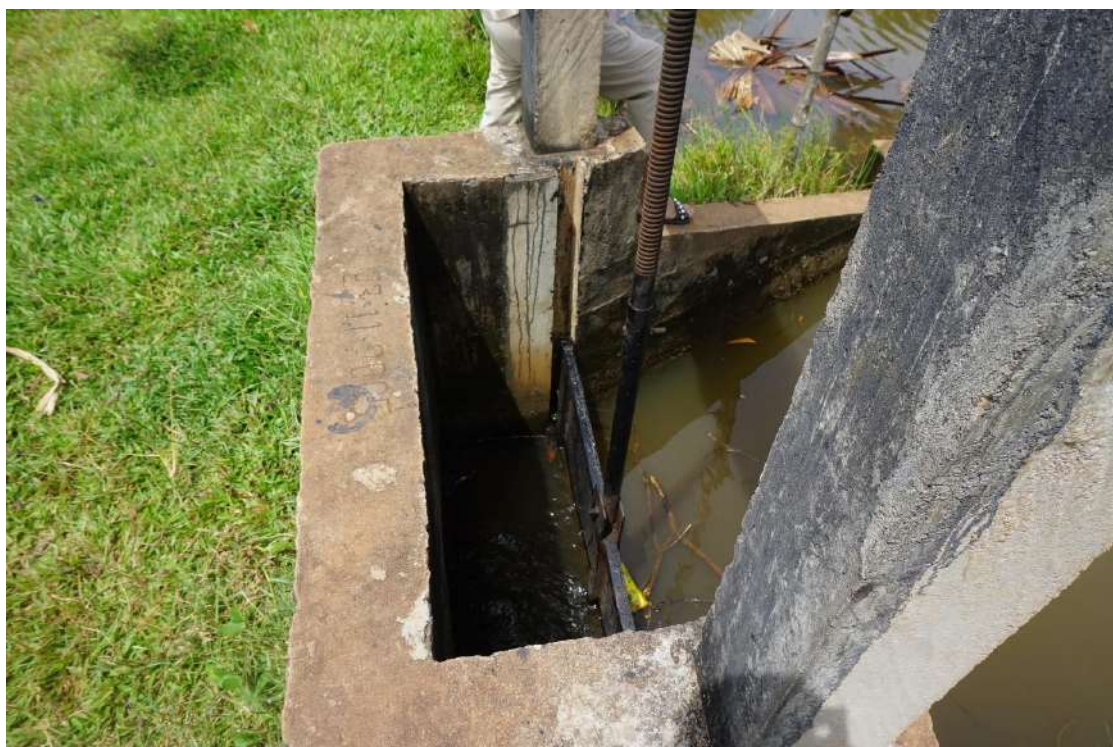
Figure 10 *“Water gate 3”*

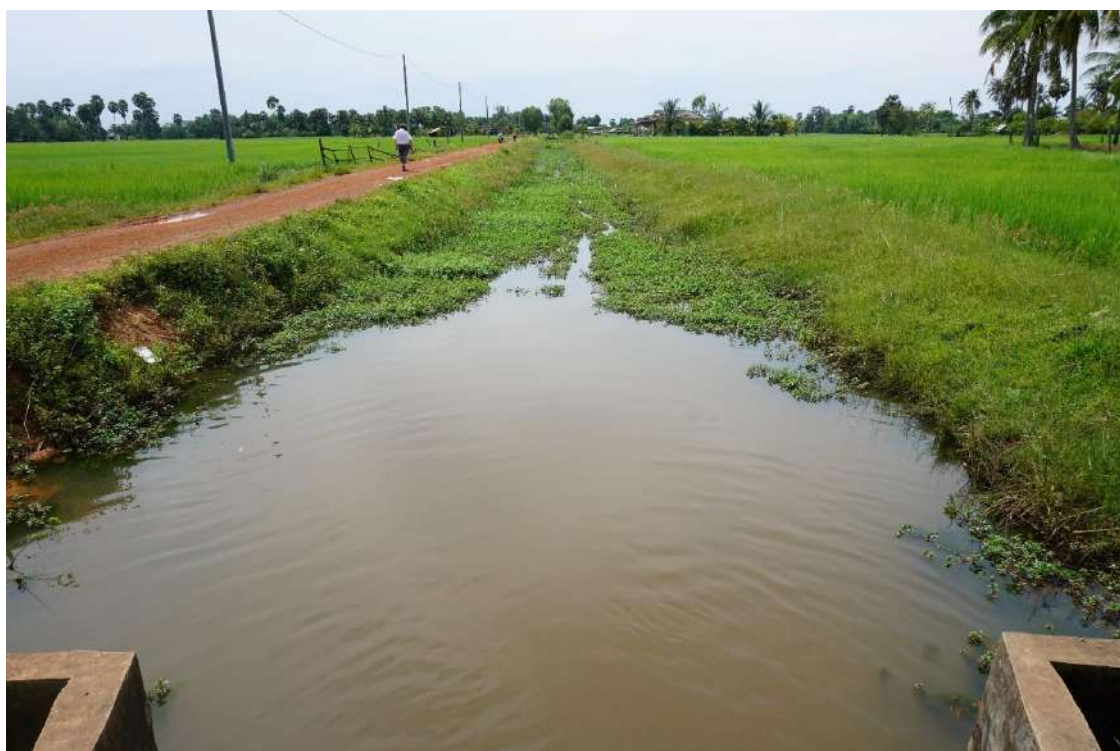
Figure 11 *“Downstream from water gate 3”*

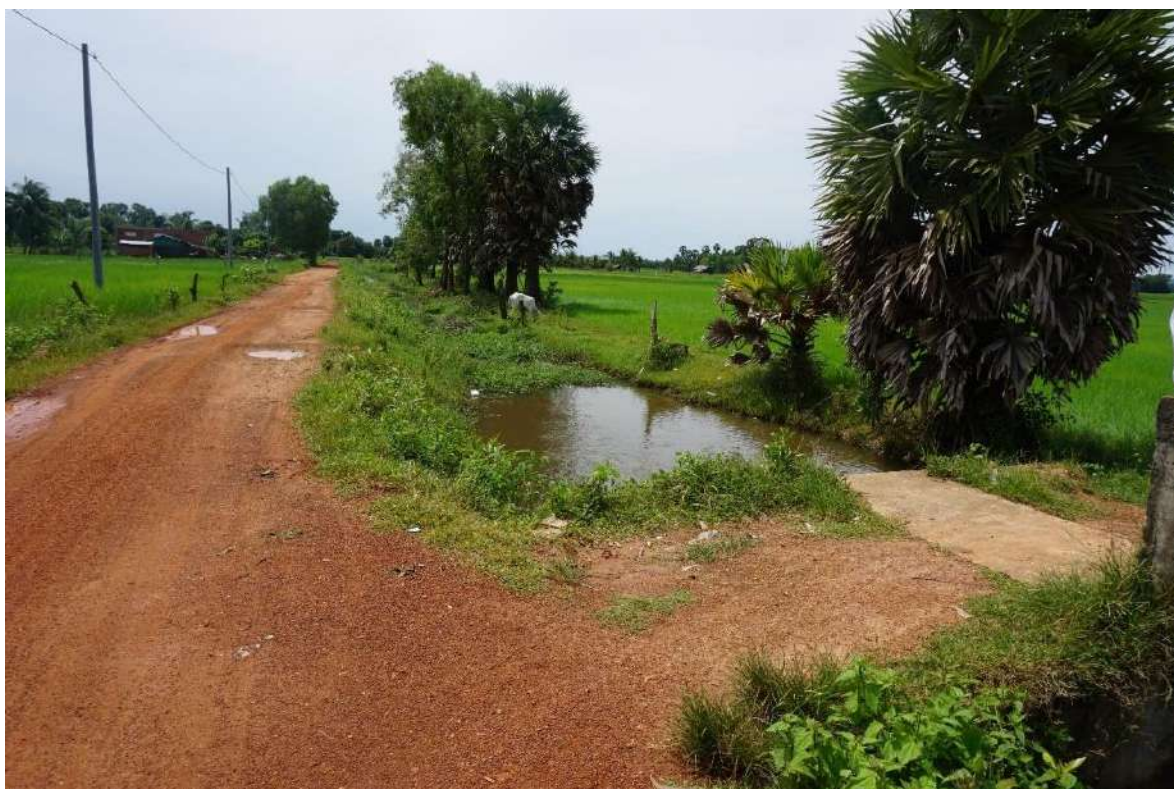
Figure 12 *“Canal downstream from water gate 3”*

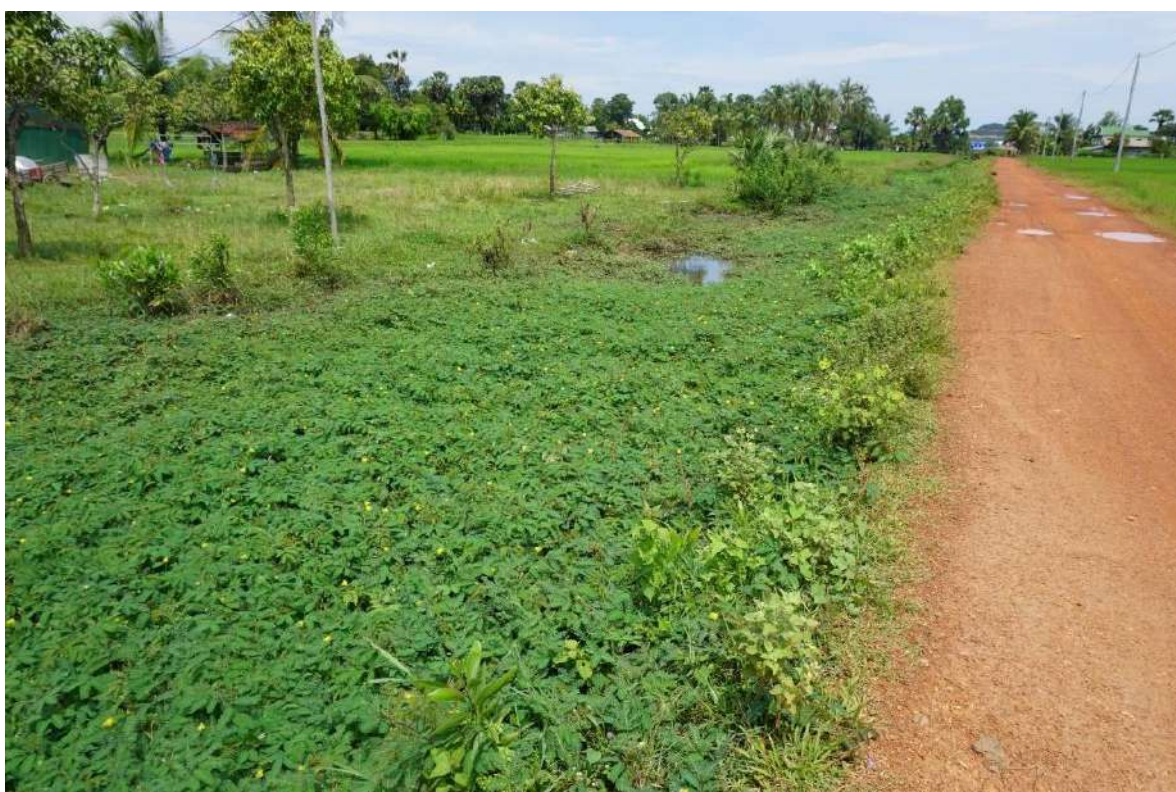
Figure 13 *“Canal downstream water gate 3”*

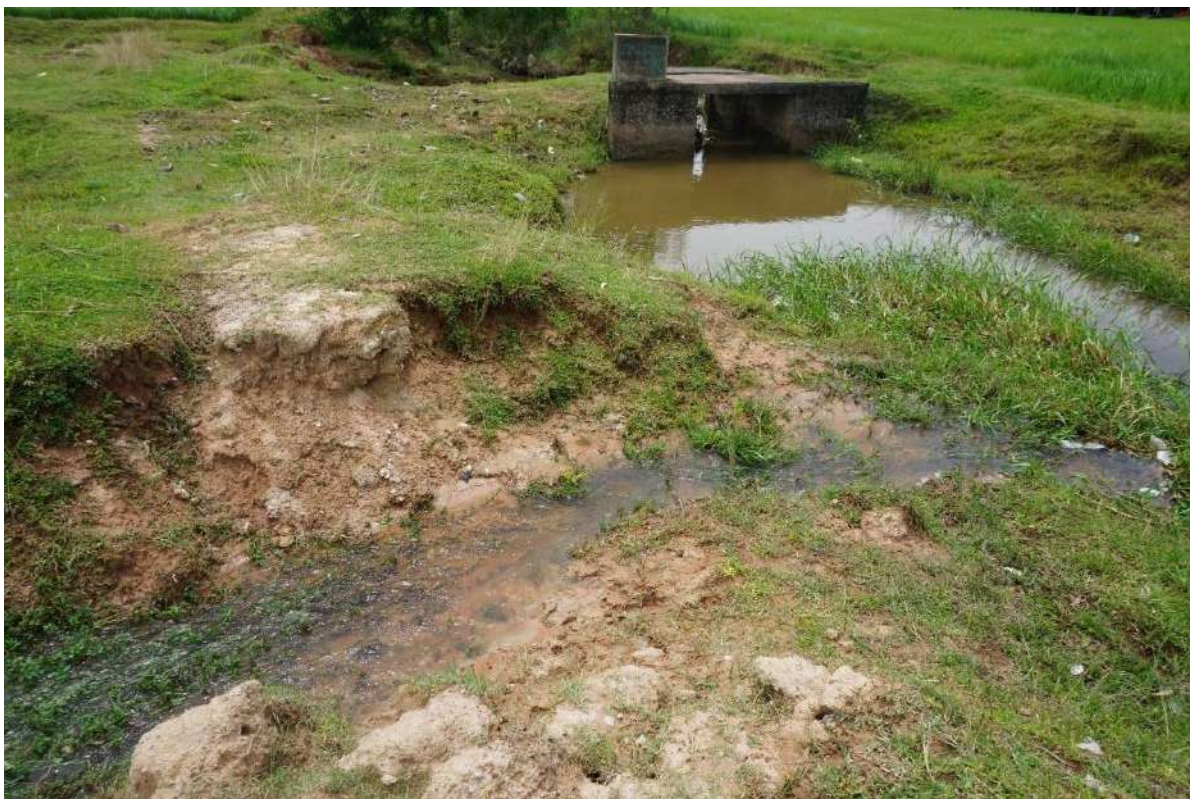
Figure 14 *“Erosion upstream water gate 1”*

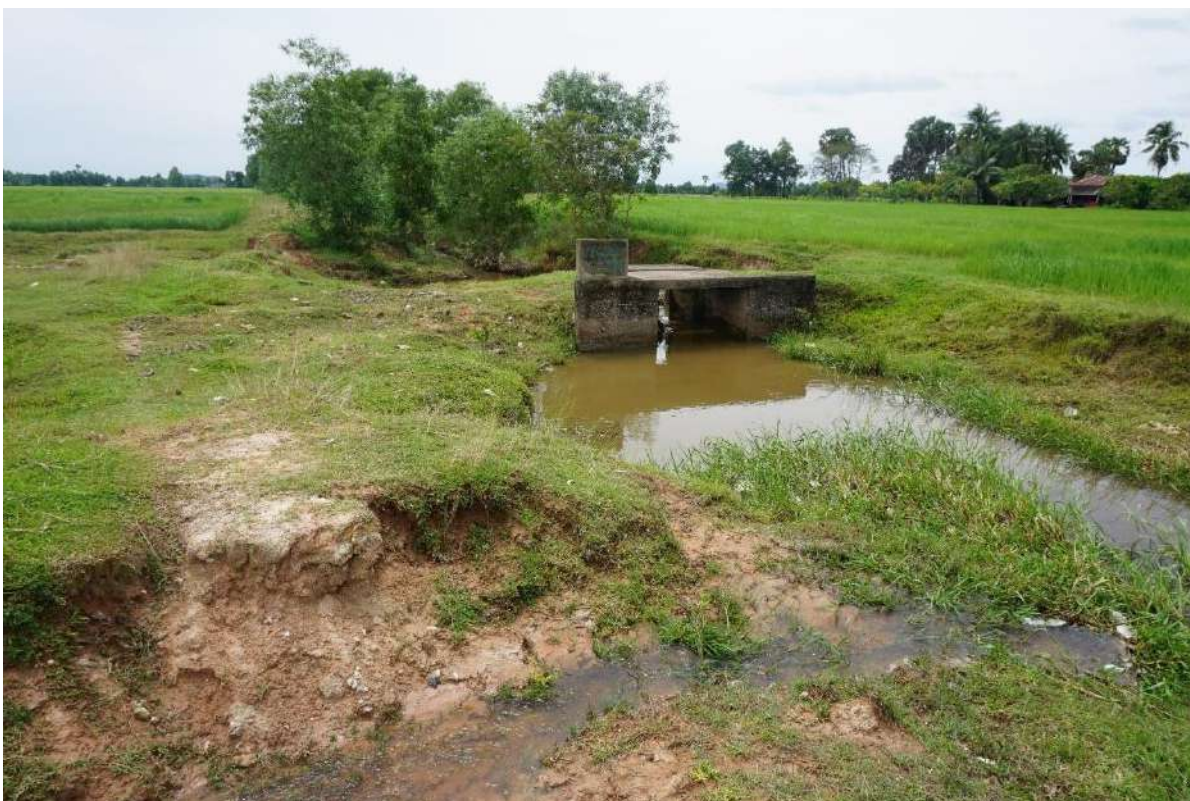
Figure 15 *“Erosion embankments water gate 1”*

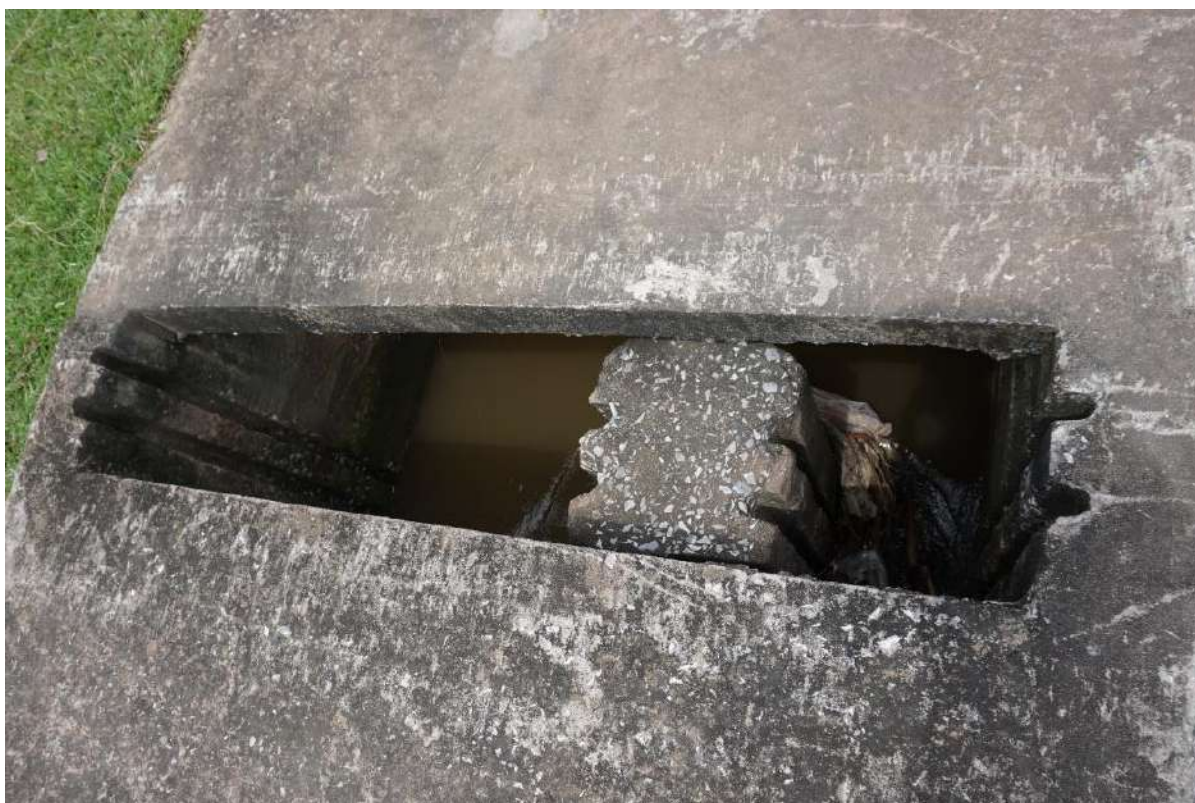
Figure 16 “Missing gate = water gate 1”

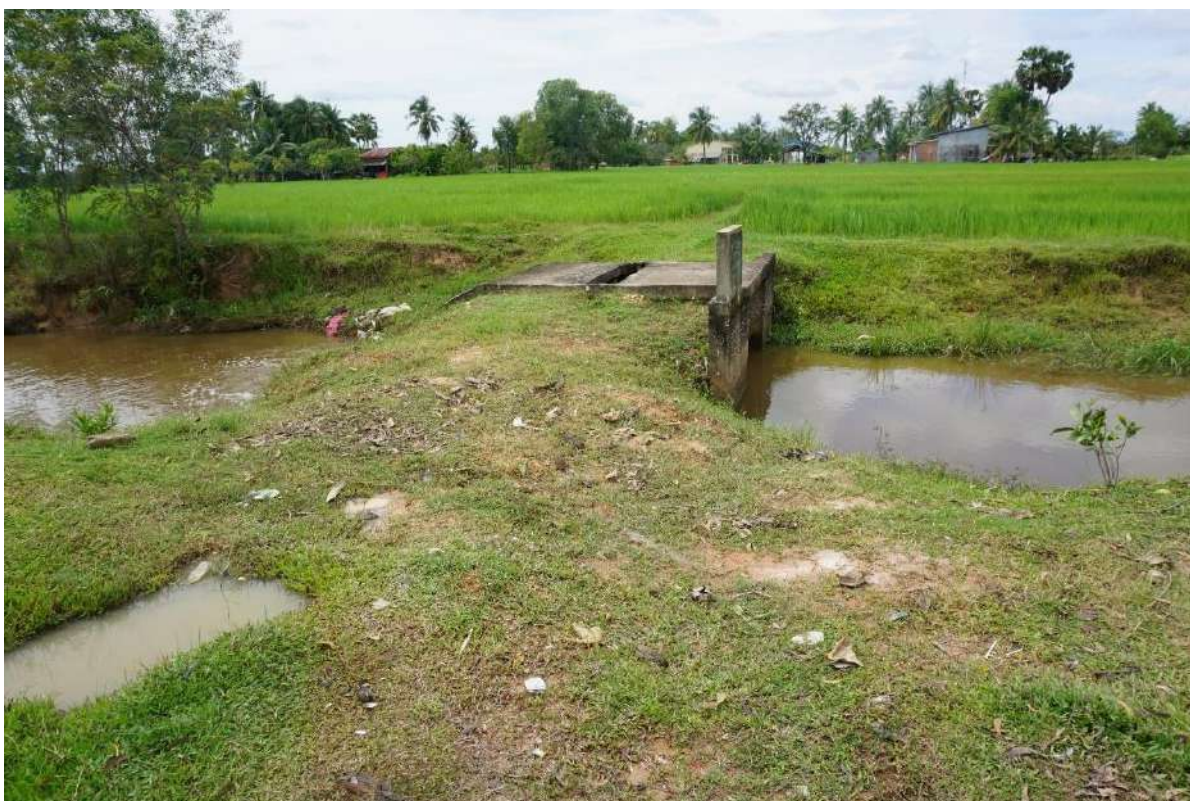
Figure 17 “Eroded embankments around water gate 1”
