FACILITATING THE REFURBISHMENT OF RONESS RESERVOIR

Sub-Project ID: 3.4b

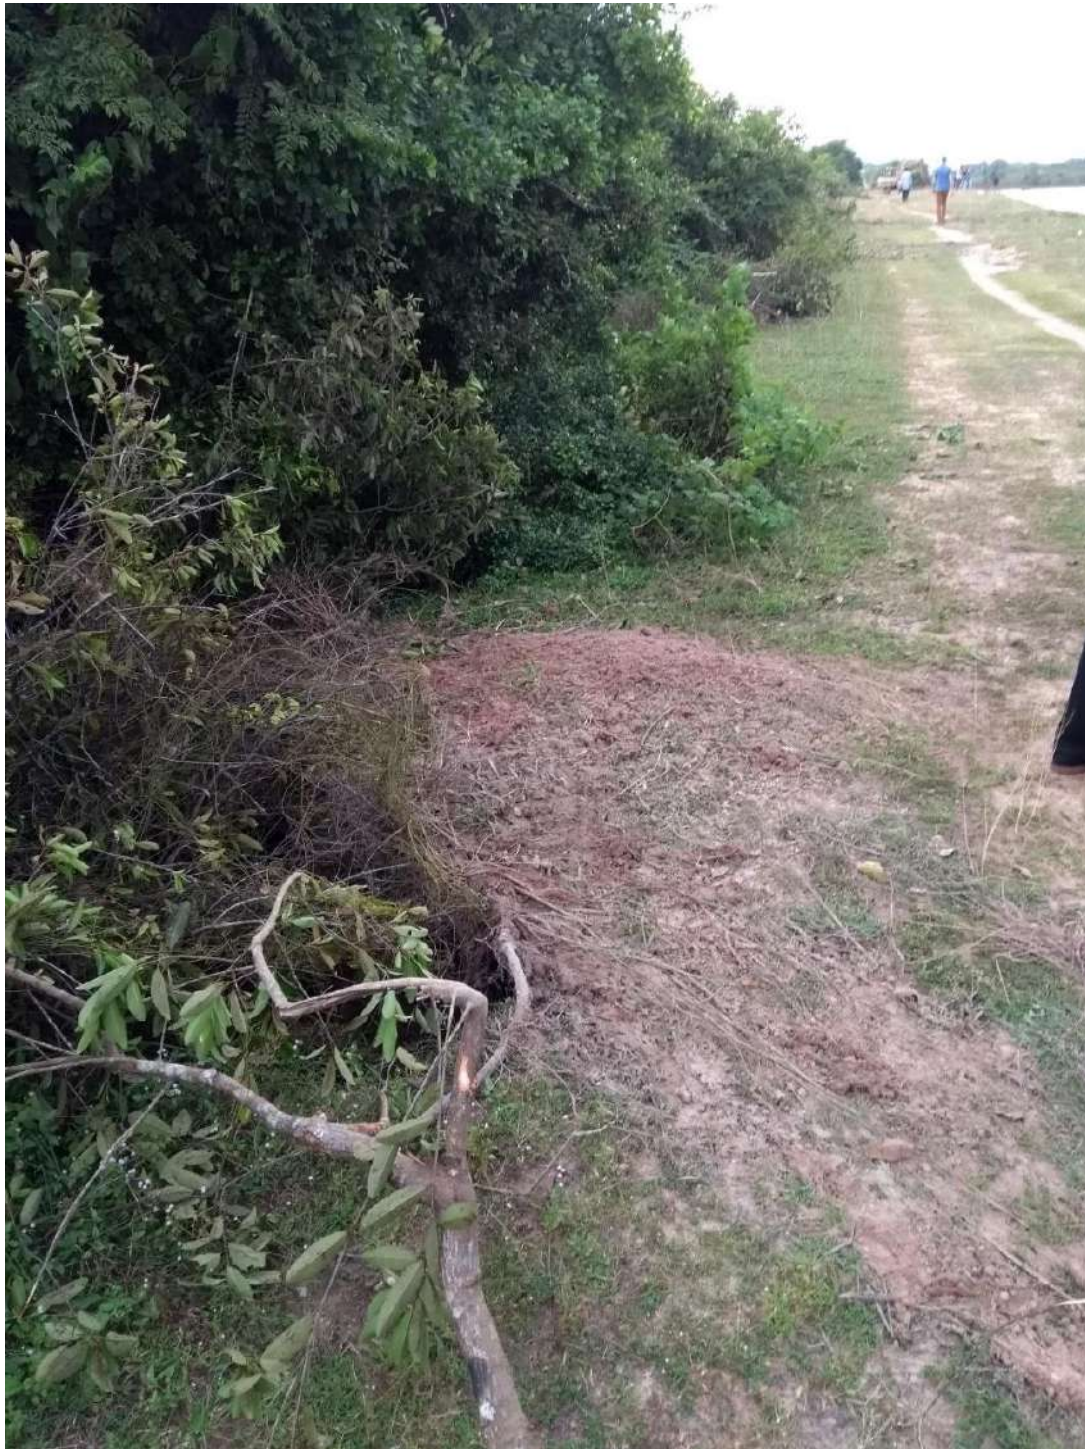
Firstly, the extent of vegetation along the embankment is both a source of weakness (there is a risk of piping along tree roots, and the root boles of fallen trees cause large-scale physical damage to the embankment) and inhibits the ability to inspect the dam for leaks and other damage. The dam should be inspected by a qualified dams engineer who can instruct on the removal or management of vegetation to minimise disruption to the embankment (felling of established trees may cause more problems with leakage pathways as the roots rot). Any damage from trees that have already fallen, or where tree boles need to be removed, should be repaired before proceeding to the second stage of work. Subject to instructions by the qualified dams engineer, the ground surface on the downstream slope should then be maintained as far as possible as simply grass cover – to enable this it is recommended the area is fenced in and grazed by goats (cattle would be too heavy and could over-graze and damage the slope).

Figure 2 *“Downstream face of the dam with dense vegetation and root bole damage.”*

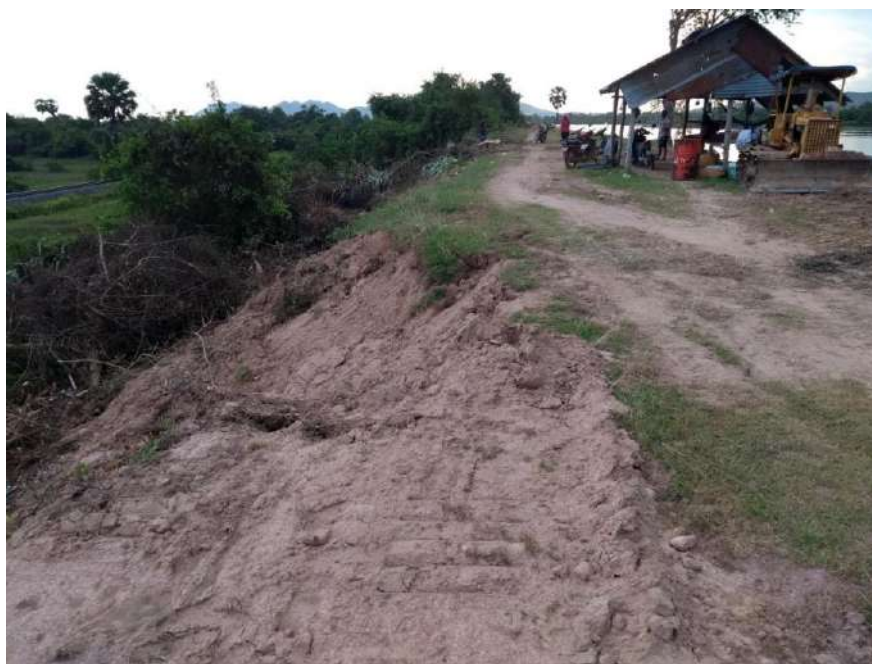
Figure 3 *“View along the crest of the dam showing eroded embankment face and vegetation on the downside of the dam”*

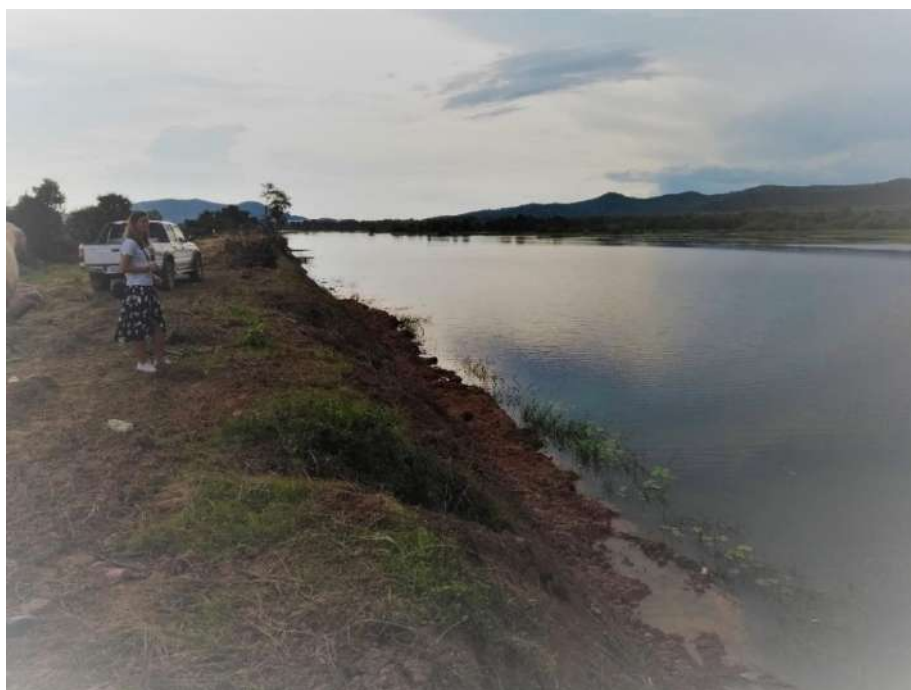
Figure 4 *“View along the upstream face of the dam showing the over-steepened and eroded embankment face.”*

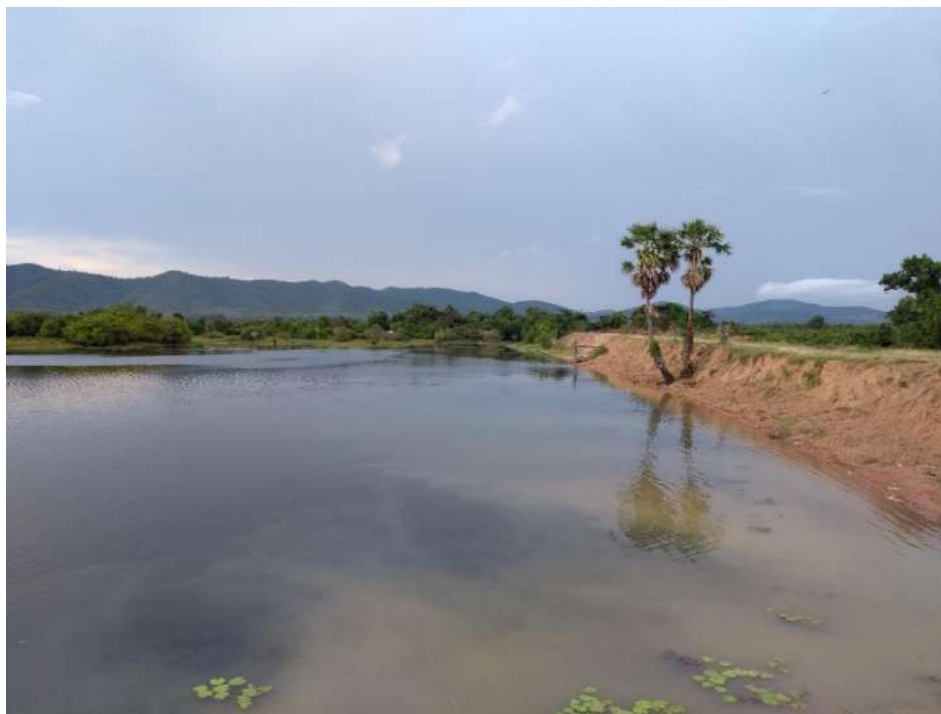
Figure 5 *“View along east side of reservoir, showing upstream face with some vegetation.”*

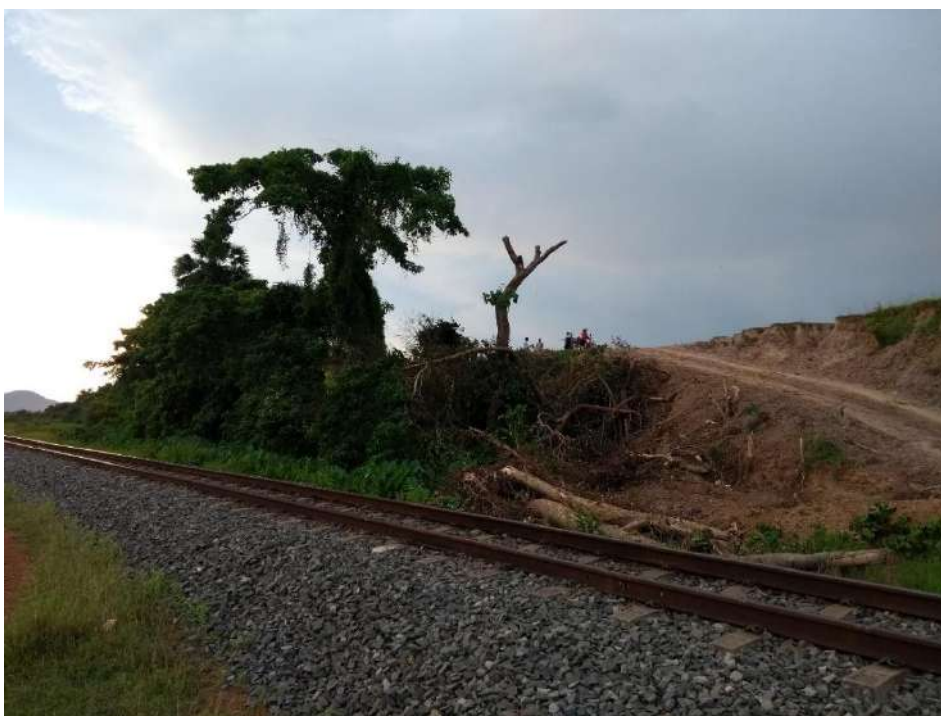
Figure 6 *“Downstream face showing access road ramp up to crest, dense vegetation and proximity of railway line.”*

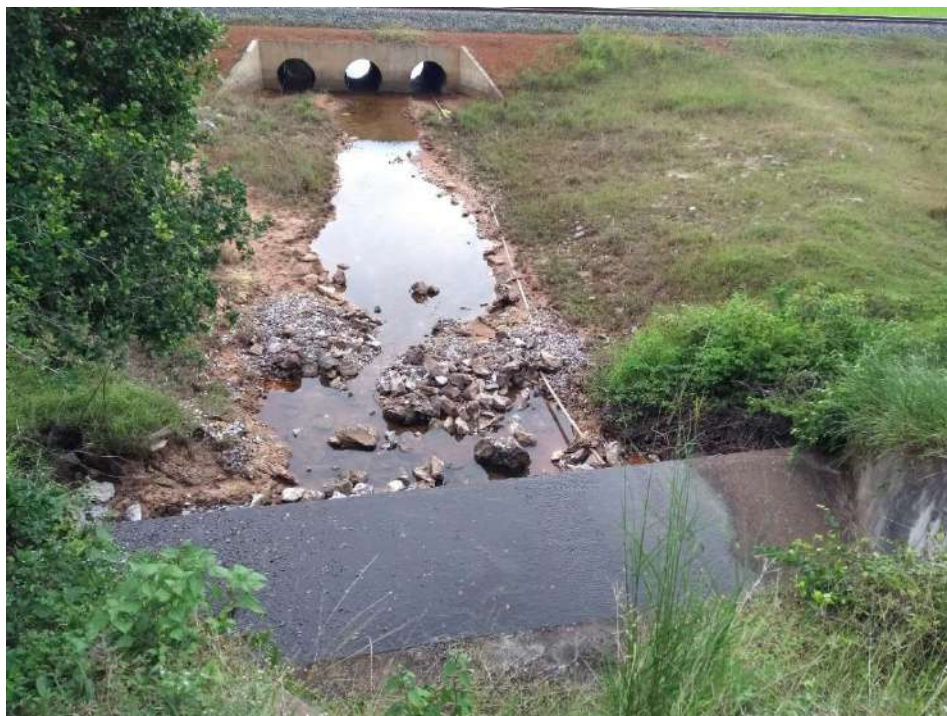
Figure 7 *“View downstream from the main outlet sluice showing the apron and the railway culverts.”*
