WATER GATE REPAIR ANGKAOL AND PONG TEUK COMMUNES

INTRODUCTION

Site Records

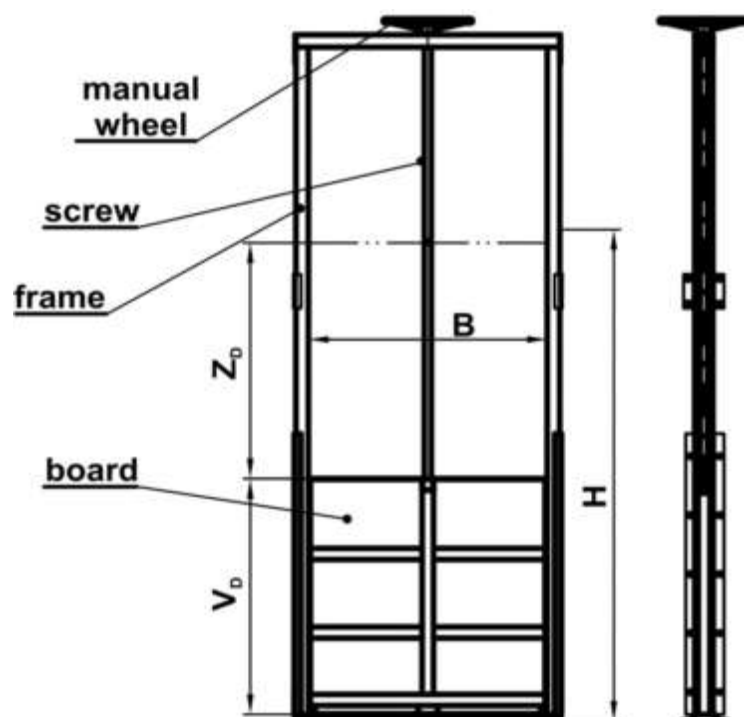
Figure 5 “Spindle design standard”

The frame supporting the spindles can be installed in the concrete frame, similar to the existing gates (figure 2). The dimensions for one of the two spindles and gate board is given in Table 1. In Figure 5 the dimensions represented in the table match the standard design.

Repair works on water gate one are slightly more comprehensive than the other gates. Water gate 1 needs a proper structure provided before two new spindles can be installed. To do so, the upper structure needs to be built with concrete and the also the lining around the gate, guiding the water, requires reconstruction.

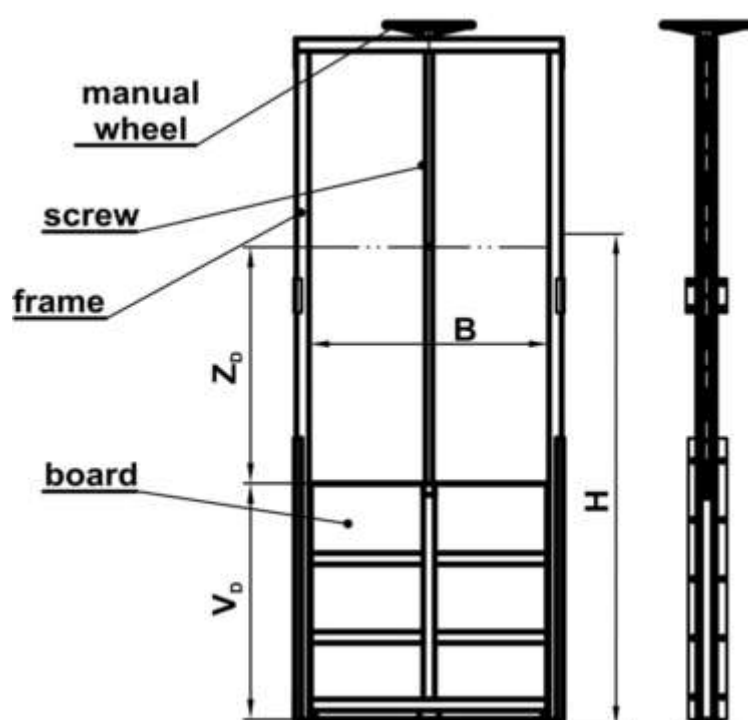
Figure 9 “Design water gate standard applied throughout coastal area”

The gates designs are standard for the area and seen throughout the province. The repair works are detailed per water gate. Mostly focusing on concrete works and precautions to prevent erosion.
